PROJECT :	Warm Roof on Concrete Standard Detail		
TITLE :	Roof Equipment Support Batten - optional (Mineral wool insulation)		
NUMBER :	SDWRC-D11b	SCALE :	1 : 4
DRAWN BY :	NKT	DATE :	31-Aug-2022
		REVISED :

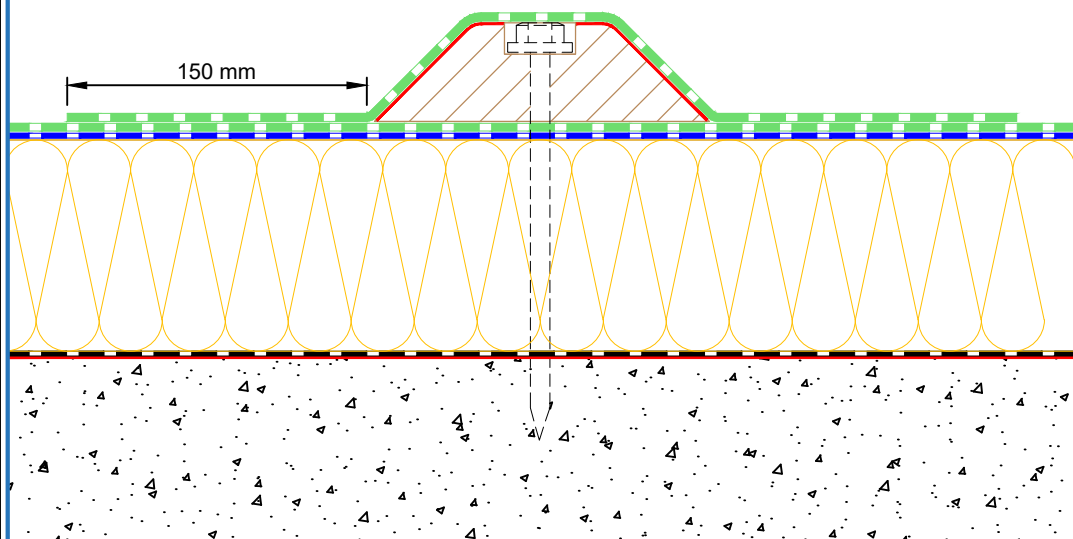
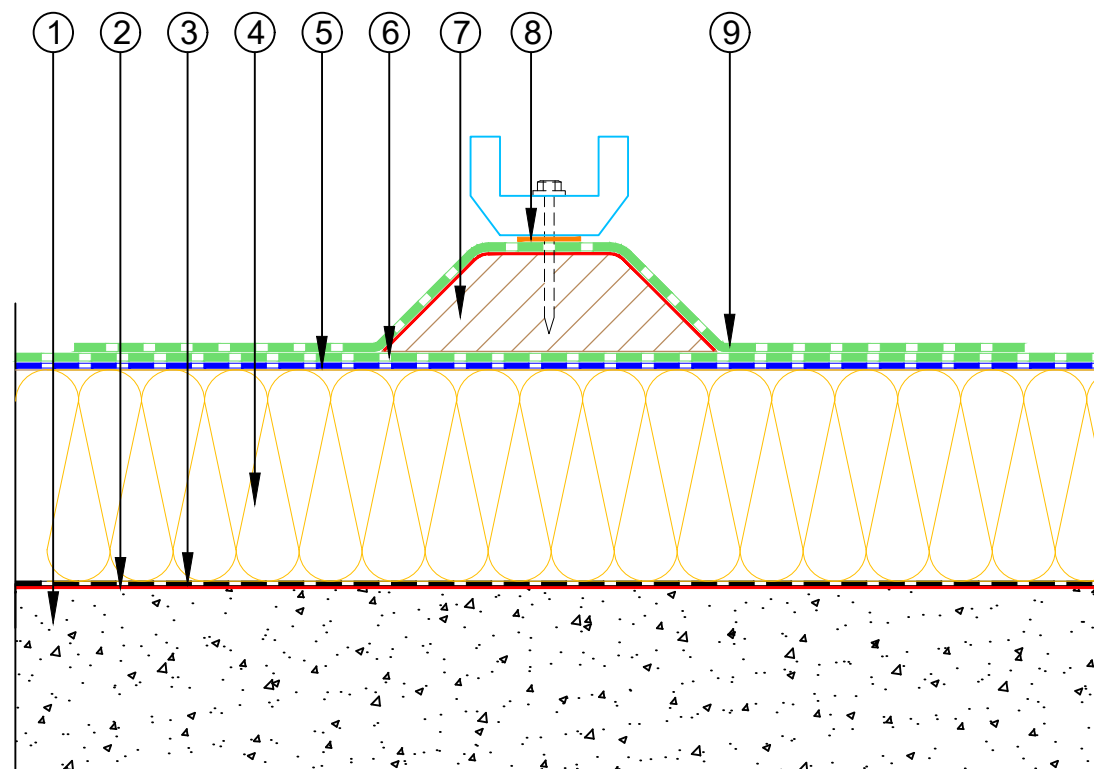
- ① Concrete Roof Slab laid to Fall
- ② EQUUS Sopradere Quick or Aquadere bitumen primer
- ③ EQUUS Debotack2.5T/F C175 or Colphene 3000 Vapour Barrier
- ④ EQUUS SOPRAROCK mineral wool thermal insulation
- ⑤ EQUUS Debotack 2.5 T/F C175 Aero base sheet
- ⑥ EQUUS DuO High Tech 4 Slates/F C180 Firecare cap sheet
- ⑦ Plywood Plinth
- ⑧ Monkey Toe Roof Profile Fixing with Neoprene Washer
- ⑨ EQUUS cap sheet as separate piece over Plywood Plinth
- ⑩ EPDM Washer under Screwhead
- ⑪ Timber Roof Batten
- ⑫ Roof Equipment

## STEP 2: Fixing of the Monkey Toe Roof Profile

### STEP 1: Fixing of the Timber Plinth
