PROJECT :	Warm Roof on Concrete Standard Detail - NOVAGLASS		
TITLE :	Monkey Toe Walkway Fixing Detail - optional (Mineral wool insulation)		
NUMBER :	SNWRC-D11b	SCALE :	1 : 4
DRAWN BY :	NKT	DATE :	22-Nov-2022
		REVISED :

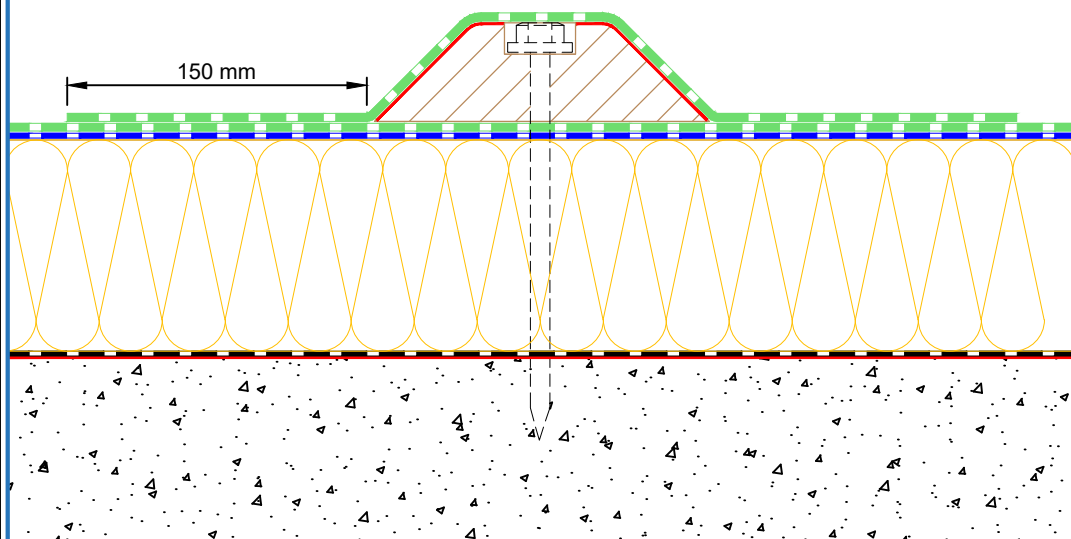
STEP 1: Fixing of the Timber Plinth

- ① Concrete Roof Slab laid to Fall
- ② EQUUS SOPRADERE QUICK primer
- ③ EQUUS Colphene 3000 Vapour Barrier
- ④ EQUUS SOPRAROCK mineral wool thermal insulation
- ⑤ EQUUS NOVA-SK base sheet
- ⑥ EQUUS NOVA-SK MINERAL cap sheet
- ⑦ Plywood Plinth
- ⑧ Monkey Toe Roof Profile Fixing with Neoprene Washer
- ⑨ EQUUS cap sheet as separate piece over Plywood Plinth
