PROJECT :	Warm Roof on Concrete Standard Detail - SOPRASUN		
TITLE :	Roof Equipment Support Batten - optional (Mineral wool insulation)		
NUMBER :	SSWRC-D11b	SCALE :	1 : 4
DRAWN BY :	NKT	DATE :	31-Aug-2022
		REVISED :

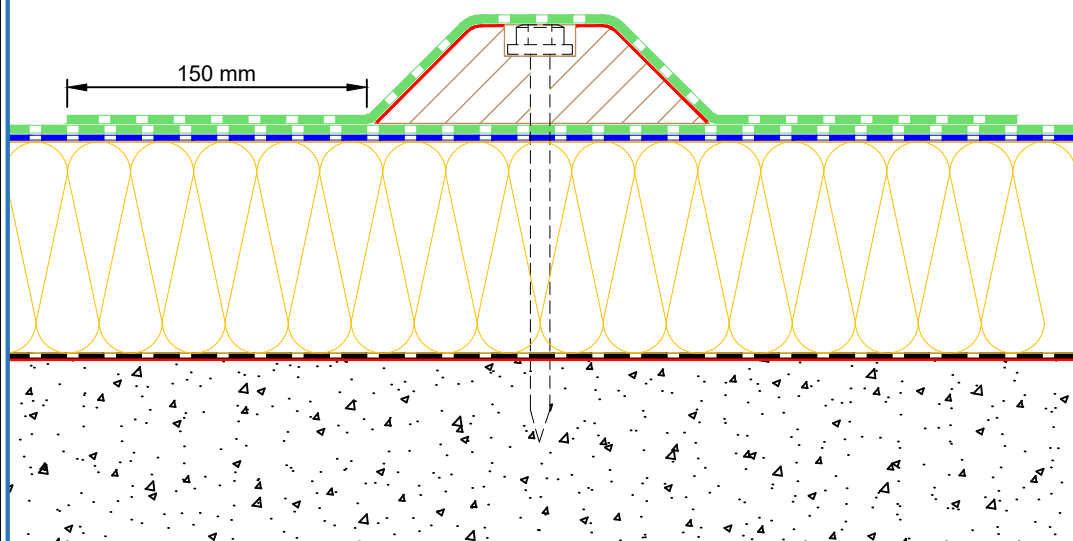
### STEP 1: Fixing of the Timber Plinth

- ① Concrete Roof Slab laid to Fall
- ② EQUUS SOPRADERE QUICK primer
- ③ EQUUS Colphene 3000 Vapour Barrier
- ④ EQUUS SOPRAROCK mineral wool thermal insulation
- ⑤ EQUUS SOPRASUN PLUS 3 base sheet
- ⑥ EQUUS SOPRASUN PLUS MINERAL cap sheet
- ⑦ Plywood Plinth
- ⑧ Monkey Toe Roof Profile Fixing with Neoprene Washer
- ⑨ EQUUS cap sheet as separate piece over Plywood Plinth
- ⑩ EPDM Washer under Screwhead
- ⑪ Timber Roof Batten
- ⑫ Roof Equipment
