PROJECT :	Standard Detail		
TITLE :	Roof Equipment Support Batten (Mineral wool insulation)		
NUMBER :	SSWRM-D7b	SCALE :	1 : 4
DRAWN BY :	NKT	DATE :	29-Aug-2022
		REVISED :

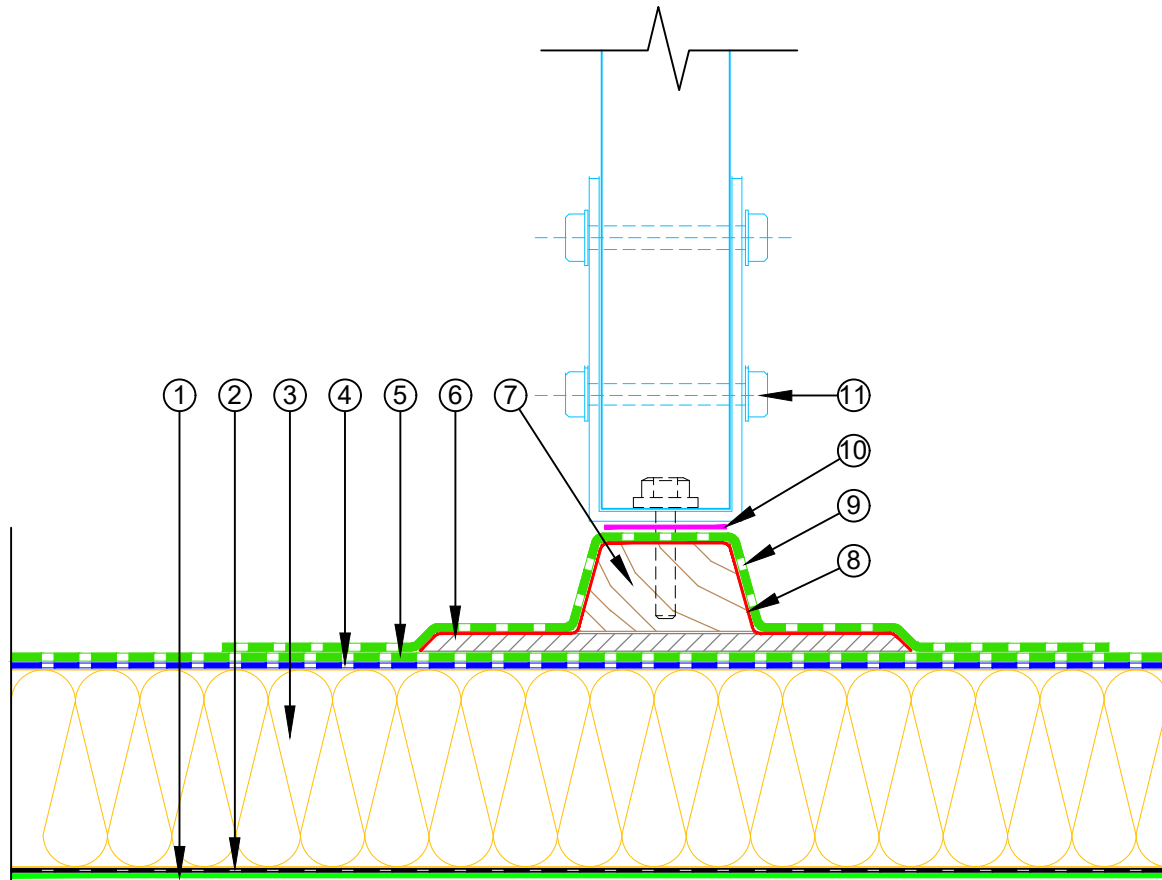
STEP 1: Fixing of the batten

- ① Metal Roof Deck
- ② EQUUS Colphene 3000 Vapour Barrier
- ③ EQUUS SOPRAROCK mineral wool thermal insulation
- ④ EQUUS SOPRASUN PLUS 3 base sheet
- ⑤ EQUUS SOPRASUN PLUS MINERAL cap sheet
- ⑥ EQUUS Permabase Dek roof cover board
- ⑦ Timber Roof Batten
- ⑧ EQUUS Sopradere Quick primer
- ⑨ EQUUS cap sheet as separate piece over Plywood Plinth
- ⑩ EPDM Washer under Screwhead
- ⑪ Roof Equipment
